# 08 REFORMAS DEL PASEO DE LA CASTELLANA

josé martínez sarandeses y  
andrés martínez gómez

## RENOVATION WORKS ON THE PASEO DE LA CASTELLANA

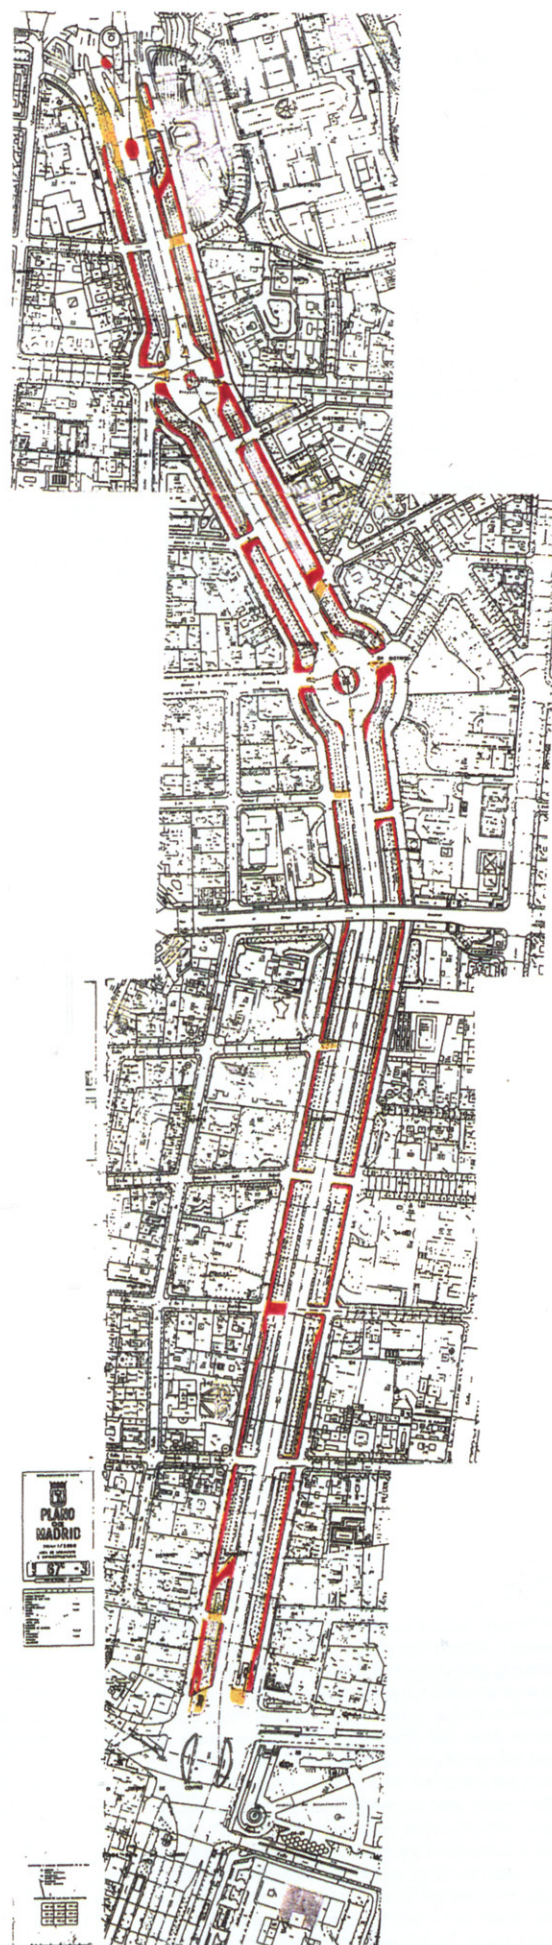
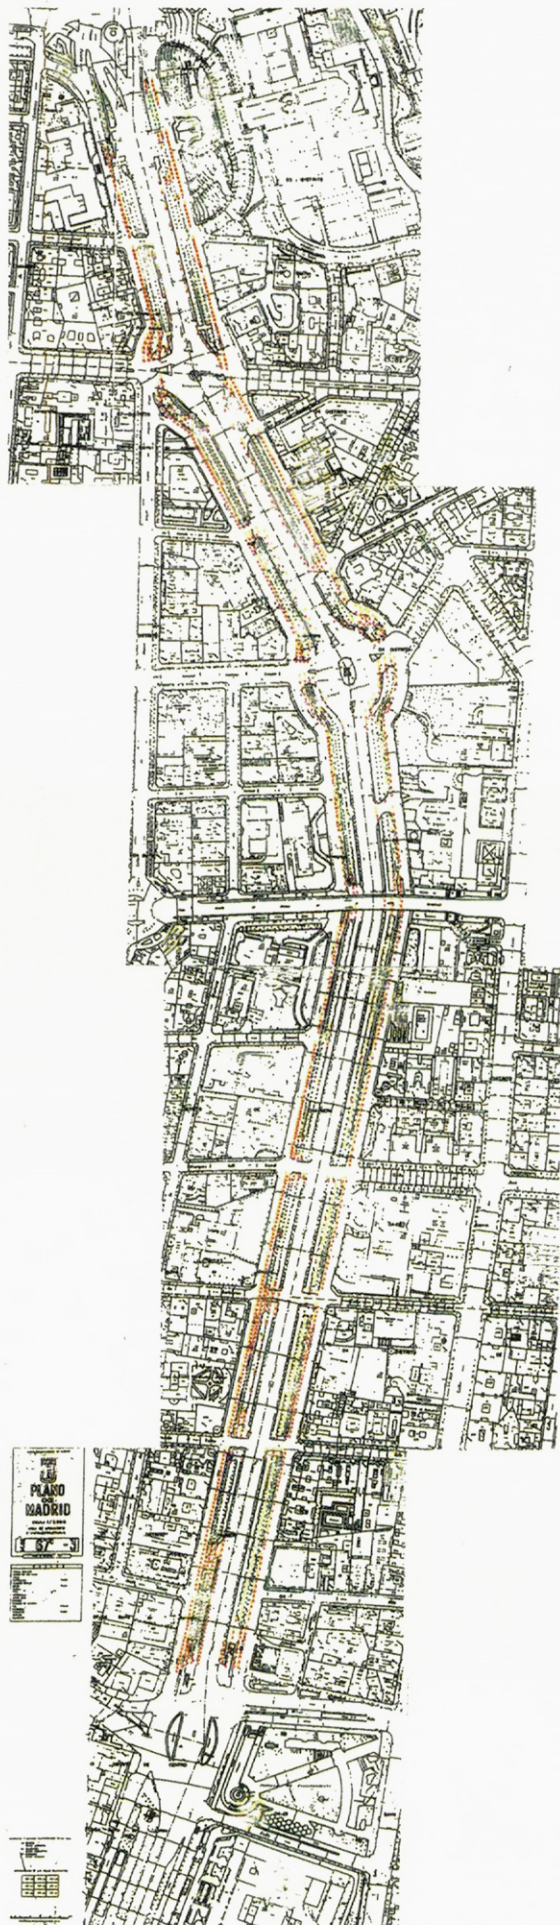
La figura 1 refleja en rojo la superficie de andén convertida en calzada, y en amarillo la superficie de calzada convertida en andén, resaltando los estrechamientos, interrupciones y acortamientos de andenes; el cuadro refleja, por tramos, las anchuras en metros de andenes y calzadas en dichos años y las variaciones que han sufrido.

02 - FIGURA 1. VARIACIÓN DE ANDENES Y CALZADAS  
(1945/1993)  
EN ROJO, ANDÉN CONVERTIDO EN CALZADA  
EN AMARILLO, CALZADA CONVERTIDA EN ANDÉN

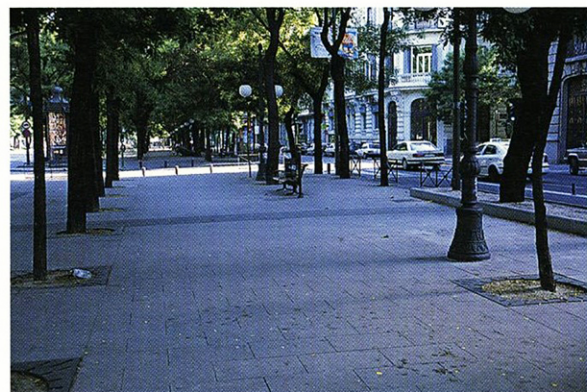
04 - CONSOLIDACIÓN DE FALTAS EN EL PLANTÍO POR EL PAVIMENTO DE LA PRIMERA FASE

Figure 3. Consolidation of faults in the grove by the paving of the first stage

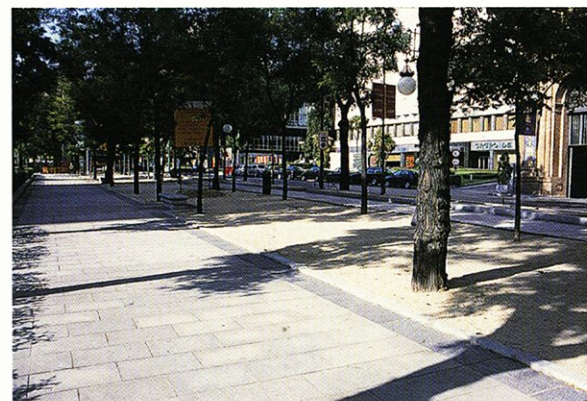
The second and third stages of the renovation affect the rest of the paseo and have consolidated the pavements' fragmentation in five strips that break their functional unity: an inclined parterre with grass and one row of trees and Ligustrum hedge, a walk paved with granite slabs separated from the parterre by a high kerb that retains surface water, a sandy earthen central zone with two rows of trees that make pedestrian use and transversal crossing difficult, another walk paved with granite slabs and a high discontinuous strip of earth with one row of trees (figure 4).

05 - FRAGMENTACIÓN DE UN ANDÉN DE LA SEGUNDA FASE Y FALTAS EN EL PLANTÍO

Figure 4. Fragmentation of pavement on the second stage and faults in the grove

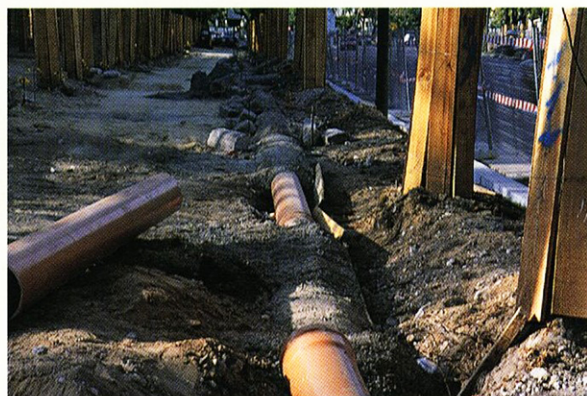
Figure 5. Concrete ditch near a row of trees

06 - ZANJA HORMIGONADA TANGENTE A UNA FILA DE ÁRBOLES

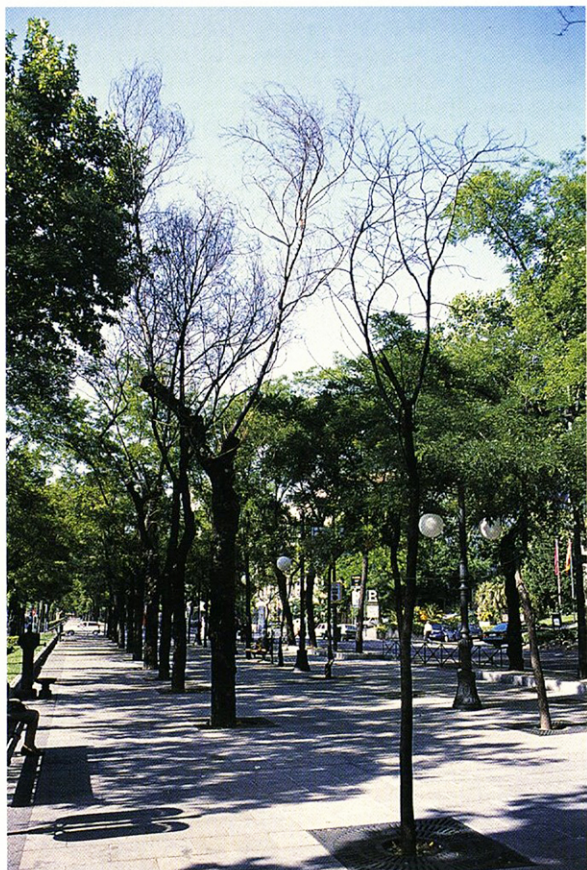
The effects of compacting, impermeabilization and paving of pavements, of directing the superficial water towards the sewers depriving vegetation of the humidity that previously penetrated through the earthen areas, of damaging the roots and the damage to trunks are there to be seen as 21 trees of the first stage have already dried up (figure 6), 70 of them have been cut down and the rest have many dry branches and damaged trunks with part of the wood rotten, which is dangerous.

Figure 6. Dried trees on the first stage

07 - ÁRBOLES SECOS EN LA PRIMERA FASE

Los efectos de la compactación, impermeabilización y pavimentación de andenes, de la conducción del agua superficial al alcantarillado privando a la vegetación de la humedad que previamente penetraba a través de las terrazas, de los destrozos de raíces y de las lesiones en troncos están a la vista, ya que 21 árboles de la primera fase se han secado, 70 han sido talados y el resto tienen numerosas ramas secas y troncos descortezados con parte de la madera descompuesta que resultan peligrosos.

We, therefore, conclude that to be consistent with its listing as Garden of interest with protection LEVEL 1 in the General Plan for pavements, it would have been better to put all the money invested into restoring the layout and the plants, recuperating the earthen areas and replanting the felled trees or changing the ones that are bad for others well formed and well planted.

Se concluye, por tanto, que, para ser consecuentes con la catalogación de Jardín de Interés con protección NIVEL 1 otorgada por el Plan General a los andenes, hubiera sido mejor destinar las inversiones realizadas a restaurar el trazado y el plantío, recuperando las terrazas y reponiendo los árboles suprimidos o que se encuentran en mal estado por ejemplares bien formados y bien plantados.
