## La cara oculta. Rehabilitaciones recientes en Budapest

### Behind the screen. Recent renovations in Budapest

Mariann Simon es profesora en la Universidad de Tecnología y Económicas de Budapest  
Mariann Simon is professor at Budapest University of Technology and Economics

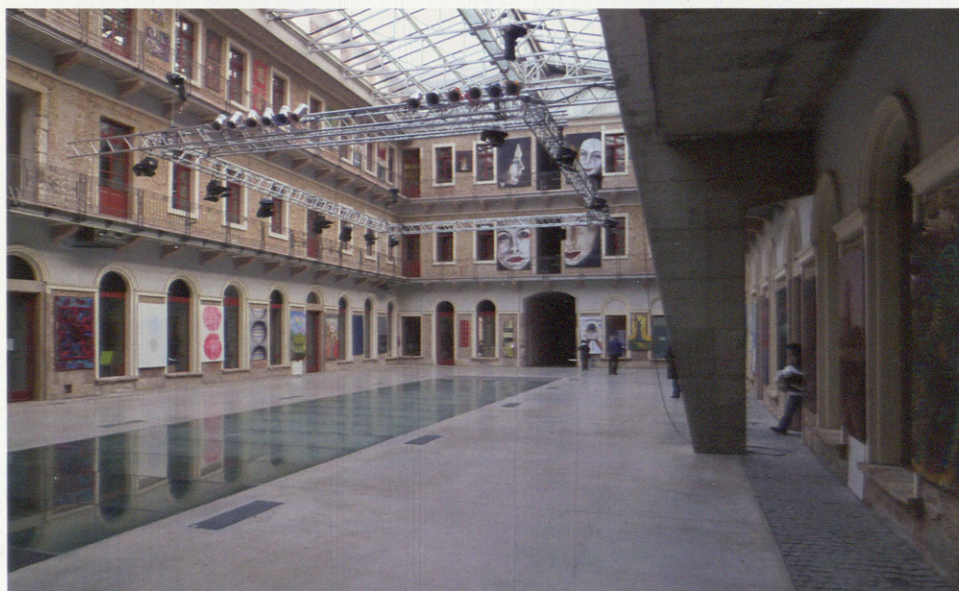
Sala principal del Centro de Diseño VAM, 2009.  
Main room of the VAM Design Center, 2009.

La renovación de este viejo edificio, construido hace ciento sesenta años, duró aproximadamente unos siete y consistió en una reforma gradual del complejo en su conjunto. El principal atractivo de la construcción –diseñada originalmente para un comerciante de vinos– se encuentra en su sistema abovedado y espacioso que imita al de una bodega. A lo largo de los años, su fachada neoclásica sufrió constantes transformaciones, por ello las obras de reconstrucción permitieron restaurar su estilo ecléctico de los años 90 dando a la fachada a pie de calle una nueva forma neutral. En el interior sólo se conservaron el hueco de la escalera y los muros de carga. Los tabiques se suprimieron para dejar espacio a las nuevas funciones: El

The renovation of the 160 years old building took about seven years, gradually reshaping the whole complex. The main attraction of the house –originally built for a wine merchant– is the spacious, vaulted cellar system. Throughout the passing years its neoclassical façade was continuously transformed, but during the reconstruction works it was restored in its eclectic style from the 1890's, while its ground floor façade got a new neutral shape. In the interior parts of the building only the main staircase and the bearing walls were kept, the partition walls were removed so as to give space to the new functions: the center includes furniture and interior design shops, an art gallery, exhibition spaces, a conference room and a wine museum. All these spaces are arranged around the main courtyard, which is visually connecting the cellar through a glass floor in the middle. The steel construction of the glass roof and the bare brick walls give an industrial look to the three storey high interior. If we add the new concrete elements of the backside, the image conversion of the former dwelling was successful.

centro incluye tiendas de muebles e interiorismo, una galería de arte, salas para exposiciones, un aula de conferencias y un museo del vino. Todos estos espacios están organizados alrededor del patio central, que se conecta visualmente con la bodega a través de un suelo de cristal en el centro. La estructura de acero de la cubierta de cristal y los muros de ladrillo visto confieren un aspecto industrial a la parte alta, de tres plantas. Si a todo ello añadimos los elementos nuevos de hormigón de la parte trasera, hemos de reconocer que el cambio de imagen de la antigua vivienda ha sido un éxito.

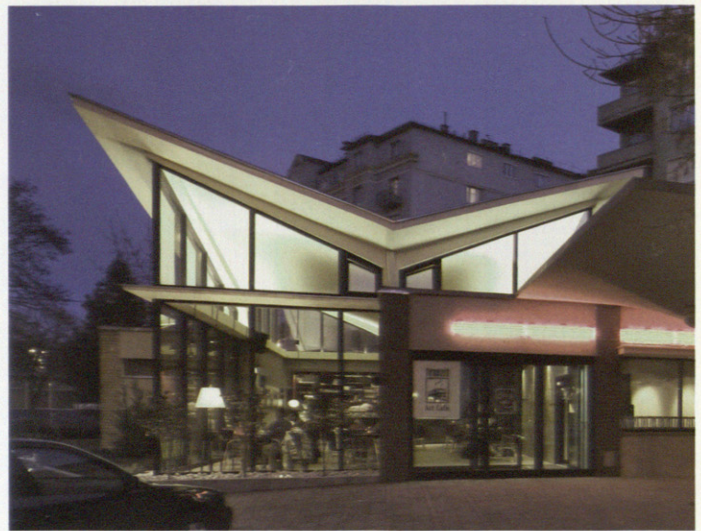
Vista exterior del Tranzit Art Café, 2009.  
Tranzit Art Cafe exterior view, 2009.

The building –originally a bus terminal– situated in the inner part of Buda was built in 1963. After it has lost its original function, due to its typical reinforced concrete structure it was listed as a monument. Although its function has totally changed –nowadays it operates as an art café giving place to exhibitions and literary evenings– the building itself went through minimal intervention. The architect approached it as an objet trouvé, which needs only cleaning. The original two solid blocks and the simple glazed room in between were kept in their original form; the brick surface of the larger block was cleaned and restored, while the smaller one, facing the covered terrace was plastered so as to soften the effect. The for-

El edificio —originariamente una estación de autobuses—, situado en la parte central de Buda, fue construido en 1963. Cuando perdió su función inicial, fue declarado monumento de interés por su característica estructura de hormigón armado. Ello hizo que, a pesar de haberse convertido en un café donde se organizan exposiciones y veladas literarias, la intervención haya sido mínima. El arquitecto lo consideró un *objet trouvé*, que sólo necesitaba una lavado de cara. Los dos bloques sólidos originales y la sala acristalada situada en medio se conservaron en su forma original; la superficie de ladrillo del bloque más grande se limpió y restauró, mientras que el bloque más pequeño, frente a la terraza cubierta, se enfoscó para suavizar el efecto visual. Por último, el antiguo hall de entrada, actualmente utilizado como cuarto de huéspedes, se acristaló con grandes losas y parteluces de acero que contrastan con la rudeza del edificio.

mer waiting hall, operating as the guest room today, was double glazed with larger slabs but with steel mullions in order to correspond with the original crude appeal of the building, which is however lightened by the garden design and the colored seats under the platform roof.
